MARYLAND HISTORICAL TRUST WORKSHEET

NATIONAL REGISTER OF HISTORIC PLACES, NATIONAL PARKS SERVICE

). NAME									
	COMMON:					, 1990 . - 1991.			
	AND/OR HISTORIC:	. • •				The state of the s			
	Pennyfield	Lock Hous	e, Lock, a	nd Stor	re Building	The continue Salangines against

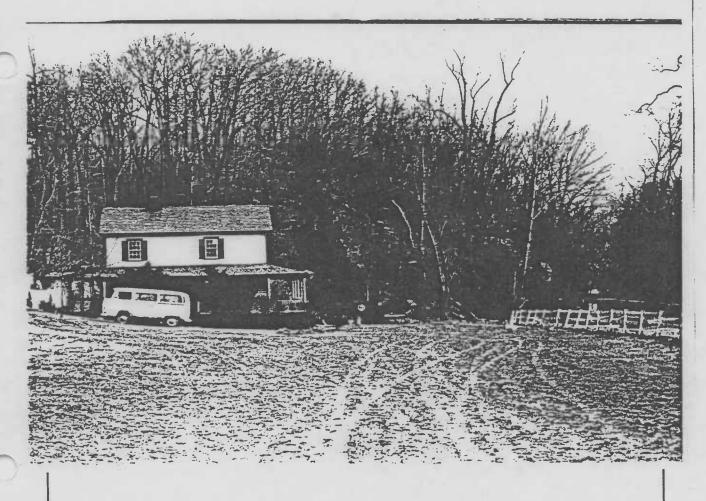
This si a typical lock keeper's house of the Chesapeake and Ohio Canal Company. It is 12 stories in height, 3 bays wide and one deep. It has a rather steeply pitched A-roof. There is a stone chimney enclosed within each end wall of the house. There is a central panelled door with an overlight.

There are no windows on the ends except at the gable levels.

The structure is built of rough fieldstone with larger squared stones for corner quoins. The door has an heavy block of cut stone for a lintel. The windows have stone sills and lintels.

There is a heavy protruding box-like wooden cornice along the roof line. The house is built on a hill so the basement becomes a full story at the rear level.

The house appears to be in the process of restoration.

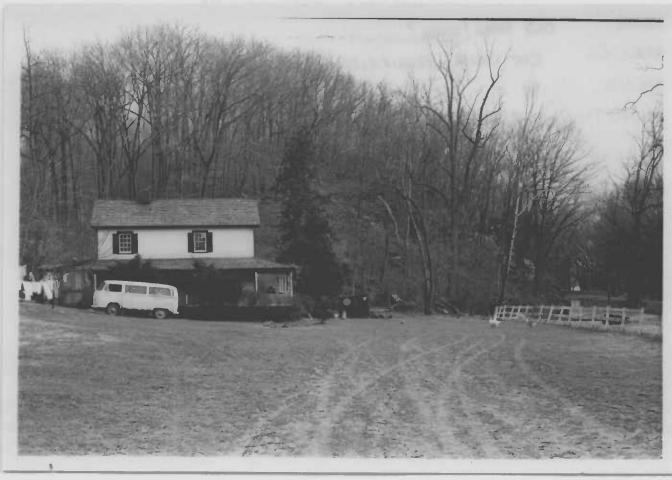
NAME OLD HOTEL/STORE?

LOCATION CHO CANAL PENNIFIELD LOCK POTOMAC, MA

FACADE W

PHOTO TAKEN 2/28/75 MOWYER
